**ILONG COMPANY LIMITED**

# **TRANSFORMER MAINTENANCE REPORT**

**PROVISION OF ELECTRICAL MAINTENANCE SERVICE FOR ELECTRICAL  
MEDIUM VOLTAGE  
SUBSTATIONS IN MONUSCO FIELD OFFICES IN DEMOCRATIC REPUBLIC OF  
CONGO (DRC) AND ENTEBBE  
SUPPORT BASE- UGANDA  
(RFP NUMBER: 3100005226)**

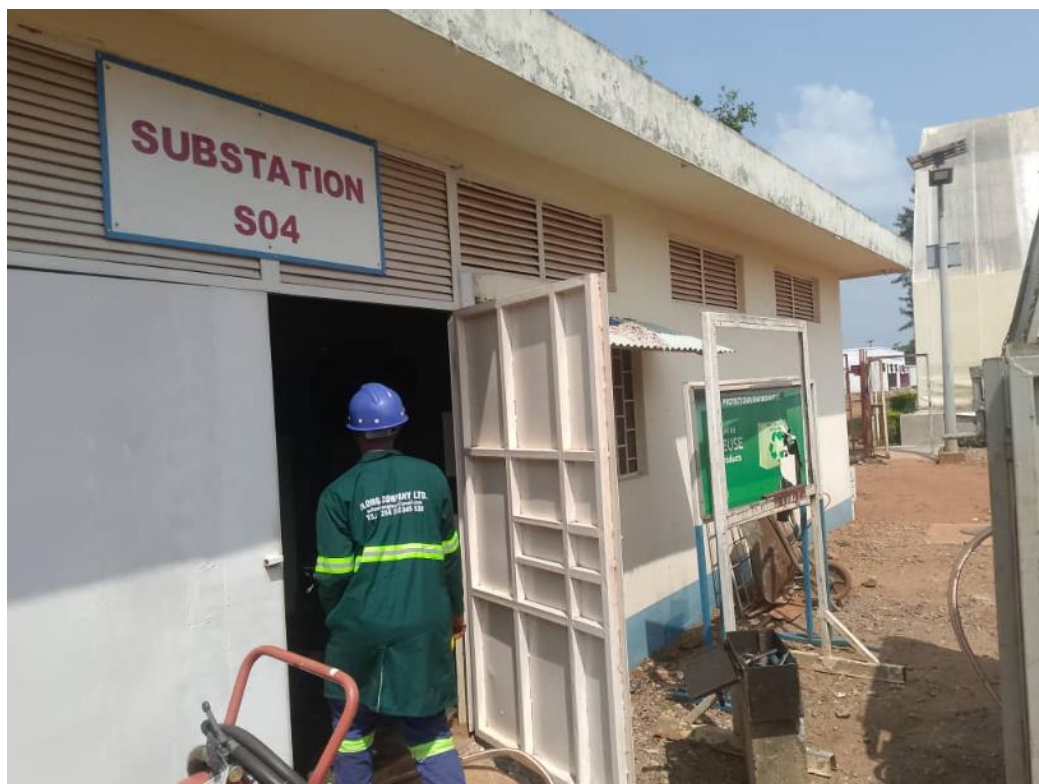
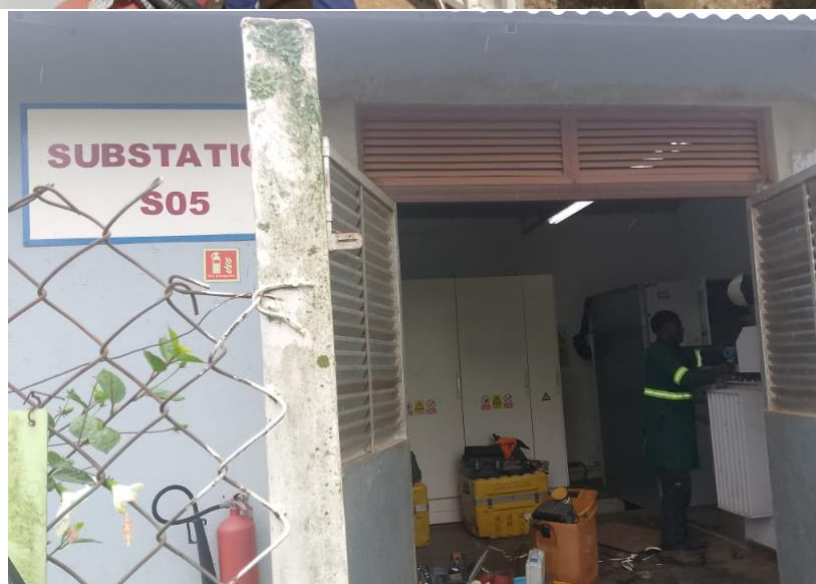
**FIGURE 1 I LONG TEAM GETTING ACCESS TO SUBSTATION NO.4 AND NO.5**

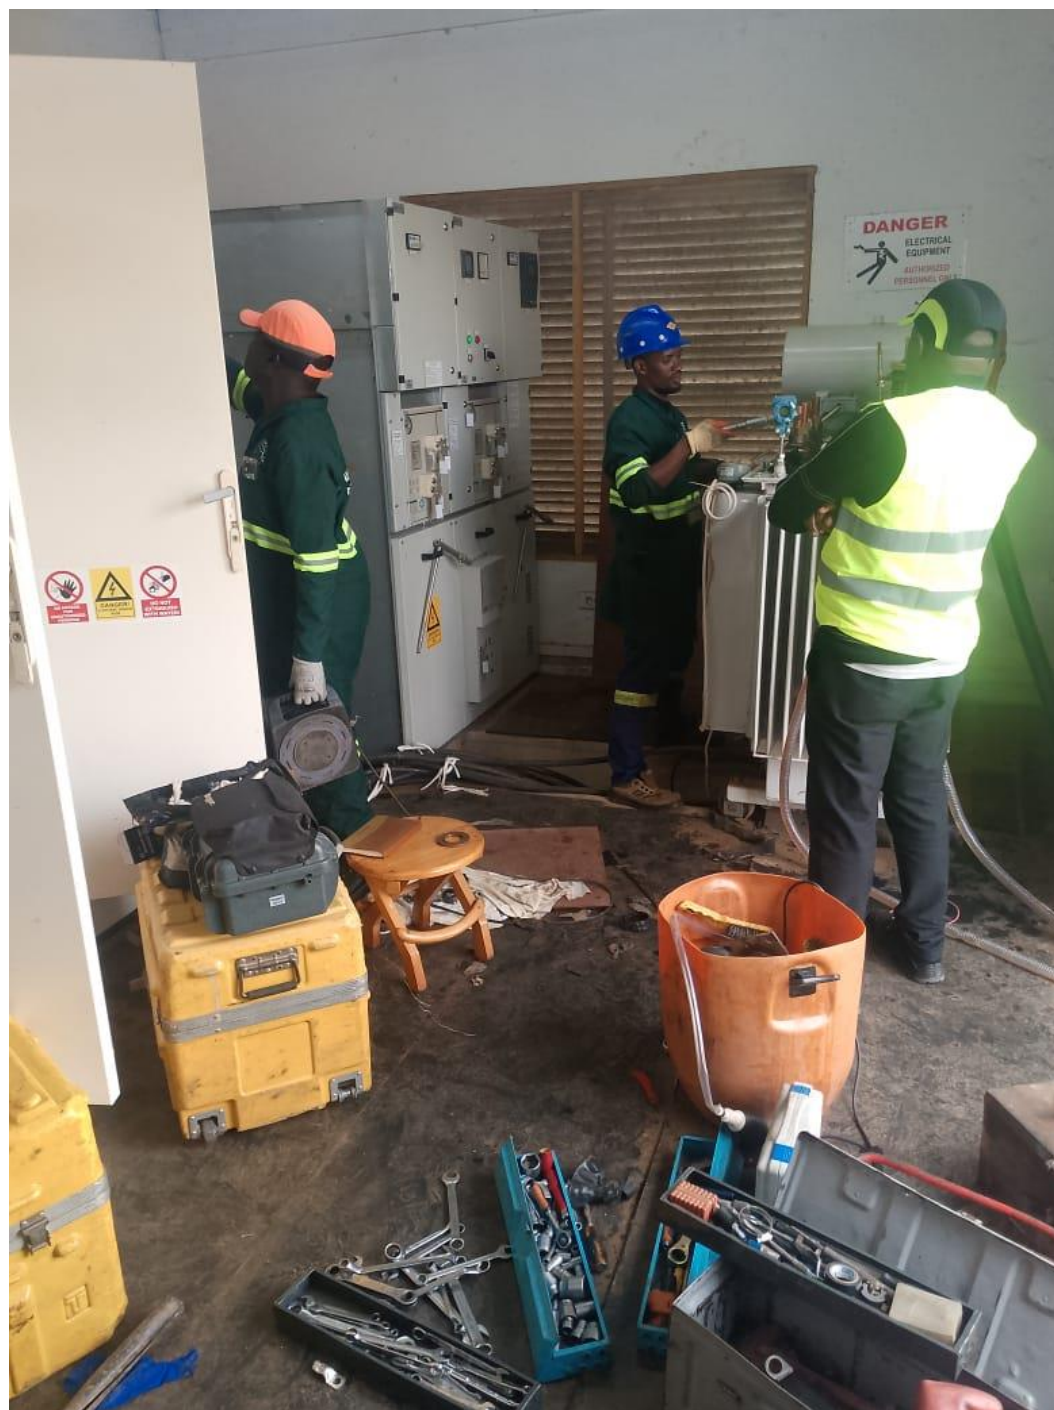
FIGURE 2 SUPERVISION FROM MONUSCO ELECTRICAL ENGINEER

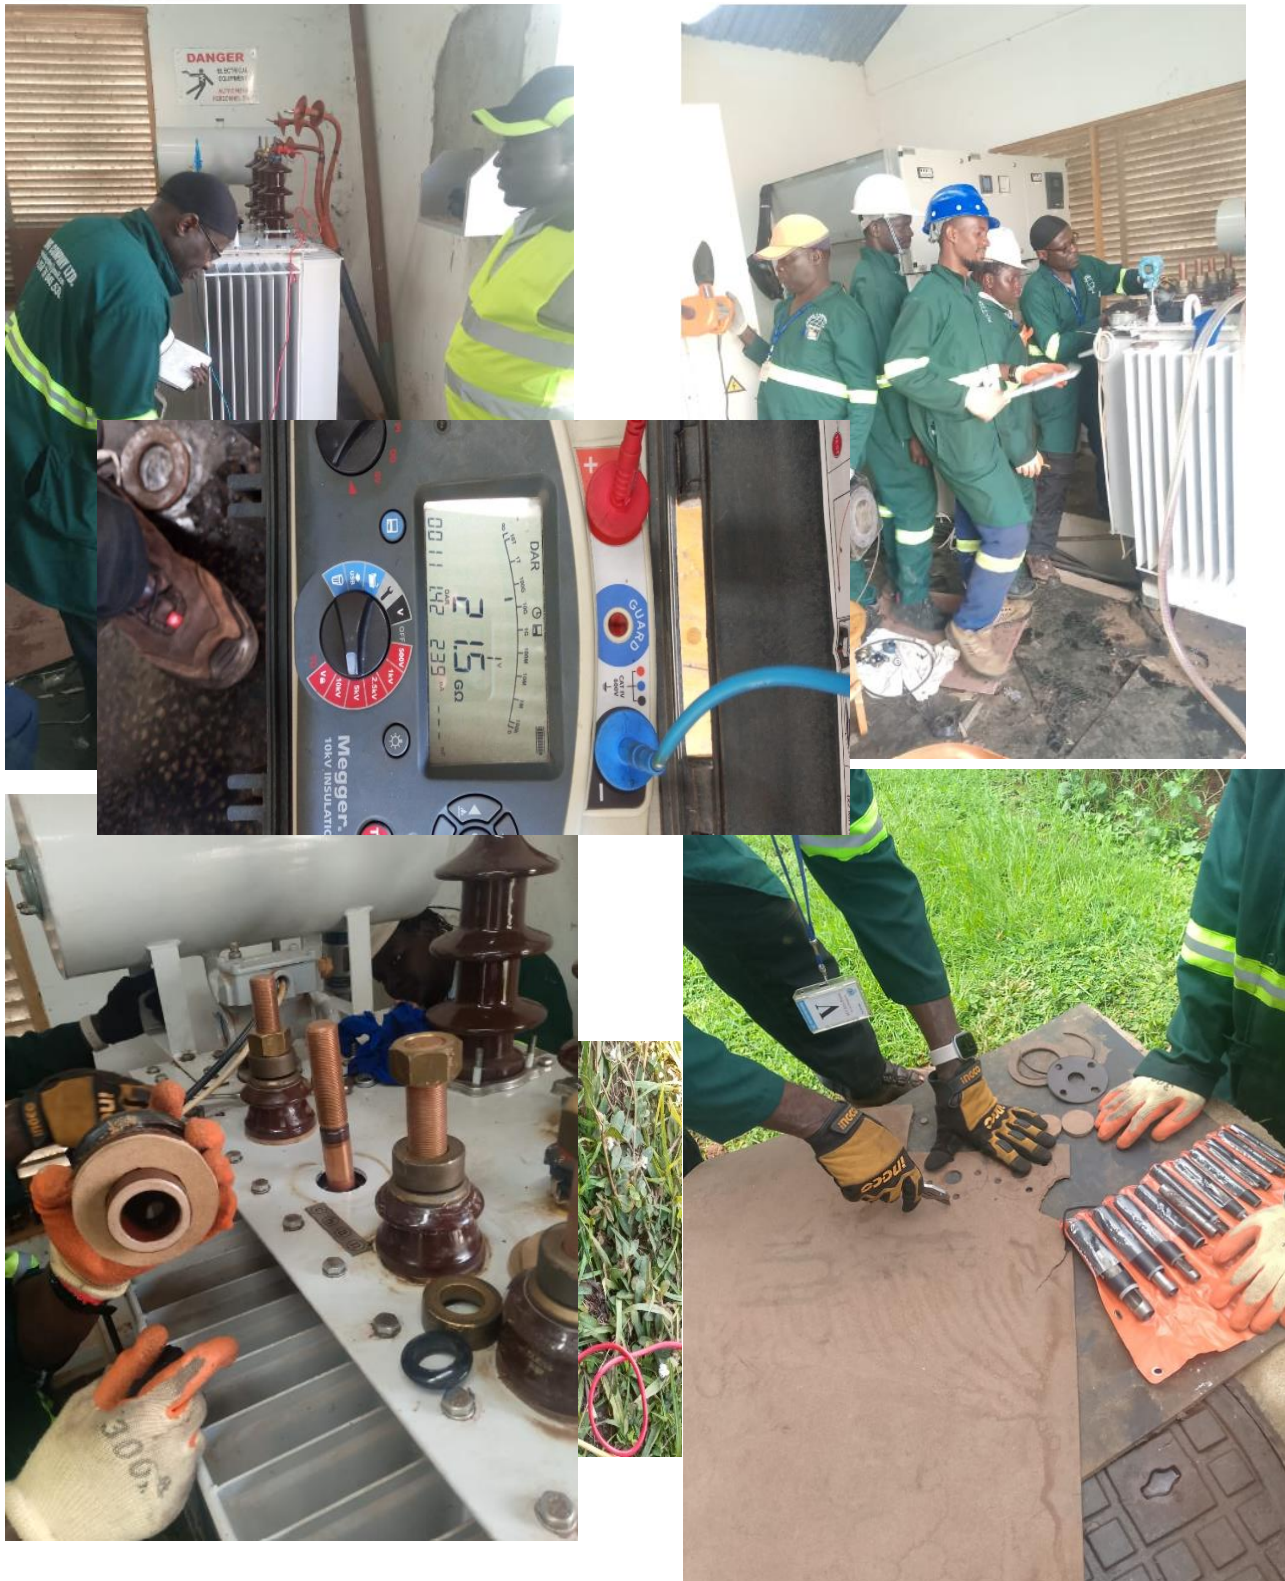
FIGURE 3 FIGURE 3 ILONG TEAM TAKING MAINTENANCE ACTIVITIES
